## BIN EL OUIDANE DAM : REHABILITATION OF BOTTOM OUTLETS

### ■ ■ ■ A Special Case

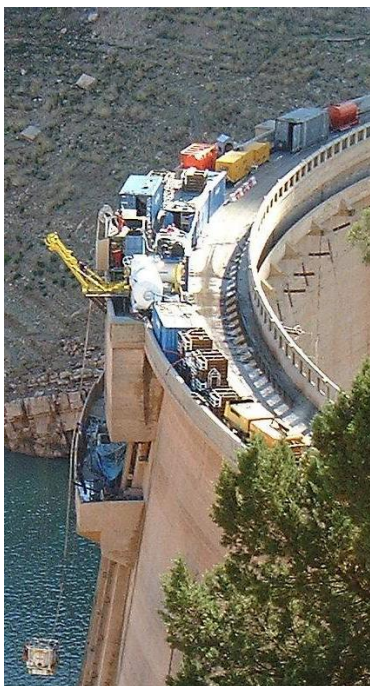
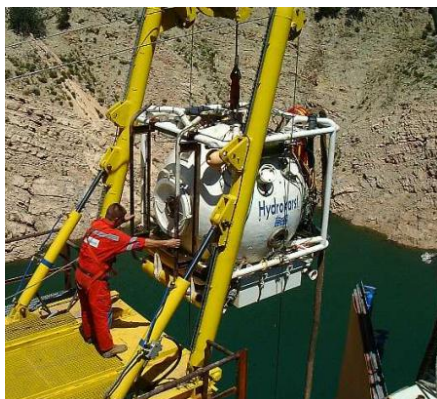
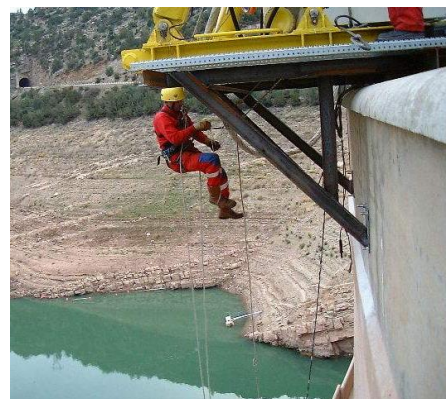
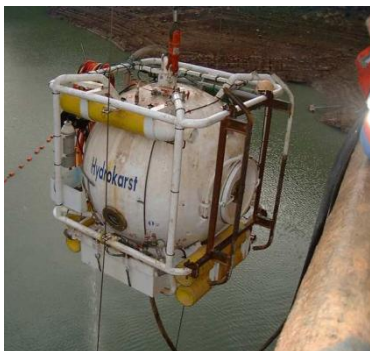
- ▷ Depth of – 80 m without possibility to lower water level of reservoir.
- ▷ 2 Bottom gates blocked and jammed under more than 20 m of sediments.
- ▷ A water intake structure not accessible by standard dredging equipment positioned on surface.
